Manhole Inspection Summary

Manhole # S11AA2001MH

Location Address: **2414 ROCKSPRING RD**

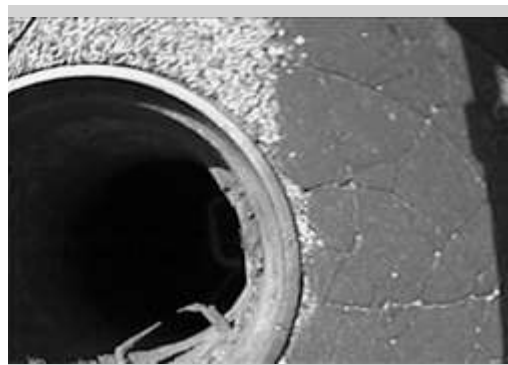
Offset: **1** (in.)

Frame offset

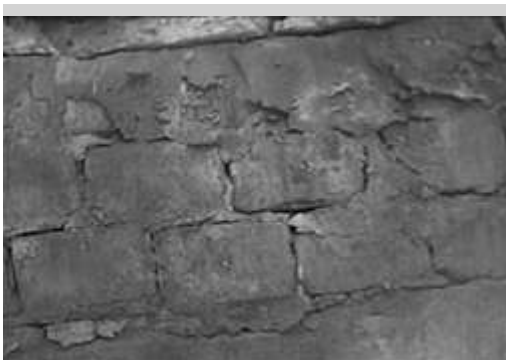
Defect

Infiltration: ☐ None ☒ **Joint** ☐ Cracks ☒ **Mortar** ☐ Roots ☐ Wall

Corbel infiltration

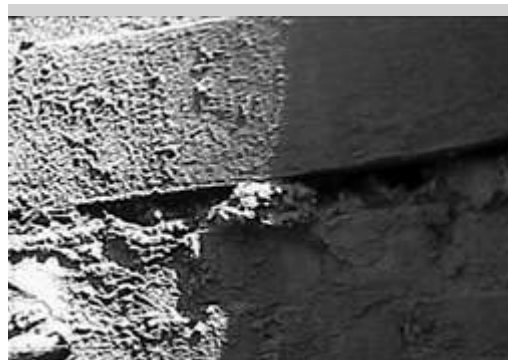
Defect

☒ **Leaks**

Infiltration: ☐ None ☒ **Joint** ☐ Cracks ☒ **Mortar** ☐ Roots ☐ Wall

Frame leak, adjustment infiltration

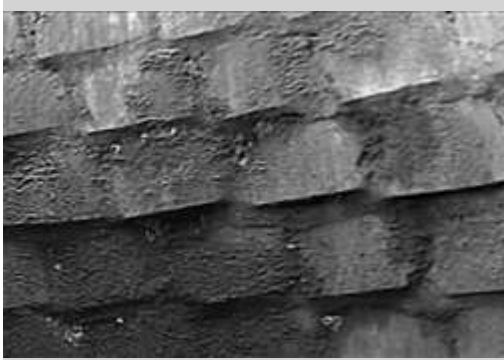
Defect

Infiltration: ☐ None ☐ Joint ☐ Cracks ☒ **Mortar** ☐ Roots ☐ Wall

Barrel infiltration.

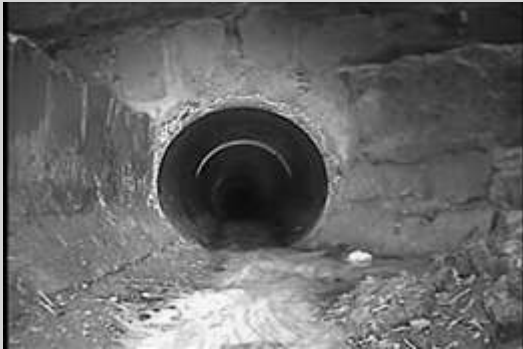
8 in. Circular Gravity Sewer Pipe Out @ 12 O'Clock

Infiltration: **Evidence** Pipe Seal Cond: **Unknown**

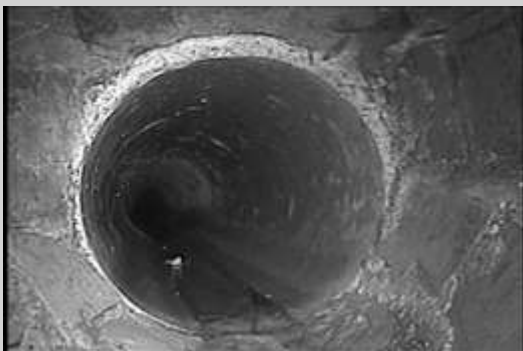
8 in. Circular Gravity Sewer Pipe In @ 3 O'Clock

Infiltration: **Evidence** Pipe Seal Cond: **Unknown**

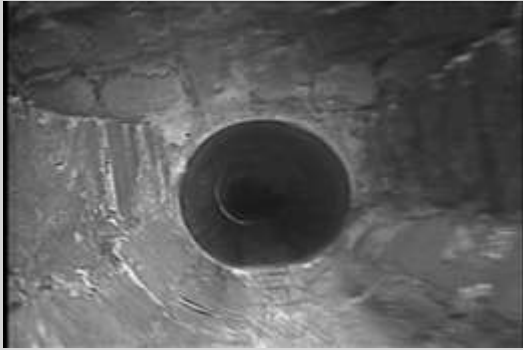
Pipe In @ 6 O'Clock

Infiltration: **Evidence**
